# **Damage mechanisms and non-destructive testing in the case of water ingress in CF-18 flight control surfaces**

Technical Memorandum

DCIEM TM 2000-098

August 2000

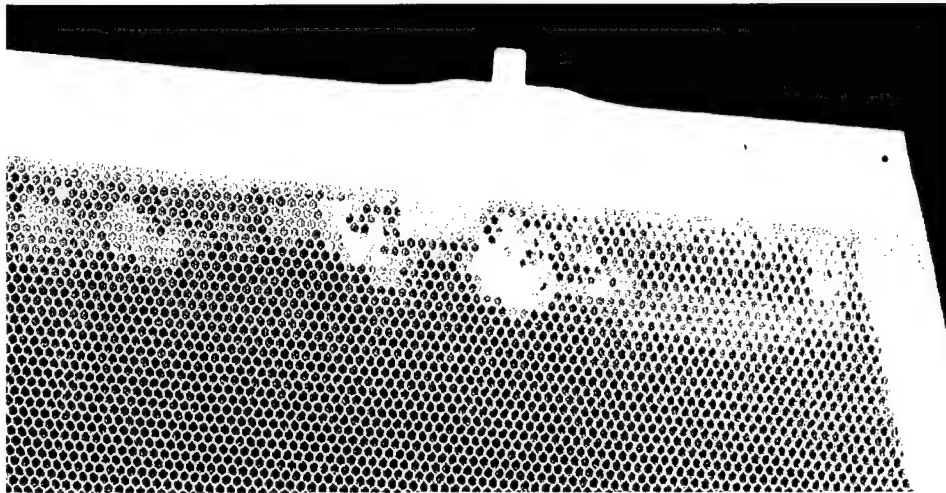
Figure 8. X-Ray inspection results showing water along the leading edge of the rudder.

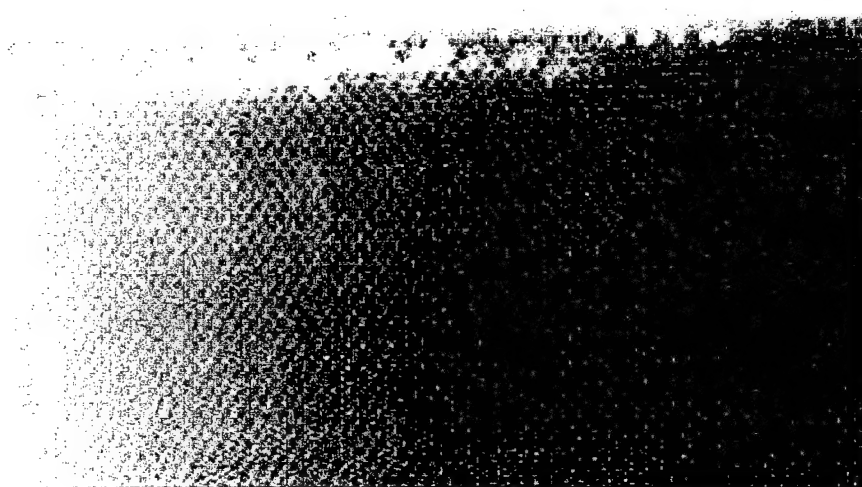
N-rays provide indications of water in individual cells (Figure 9) as well as extremely low levels of moisture (i.e., cell hydration). This capability is attributed to the neutron's characteristic attenuation by elements of low atomic numbers, such as hydrogen. Other indications found by neutron radiography include moisture in repaired areas where sealant had been injected, blown core where water may have frozen and expanded, voids in the sealant of repair patches, inconsistencies and porosity in the original sealant, repaired damage in the honeycomb, and foreign object debris. N-ray also has the potential to detect disbonds, core damage and corrosion provided that technicians have proper training and experience.

Figure 9. Neutron radiography inspection results.
